# CHALLIS AIRPORT

This report describes how your pavement maintenance management program was developed. This program was developed as part of the Network Pavement Management Program project sponsored by the Idaho Transportation Department, Division of Aeronautics. The information and data contained in this report ensures you are in compliance with the requirements of Federal Aviation Administration (FAA) Grant Assurance Number 11 which states that any airport requesting federal funds for pavement improvement projects must have implemented a pavement maintenance management program (PMMP).

Figure CH-1. Airport Layout, Dimensions and Pavement Cross-Sections.  
Challis Airport

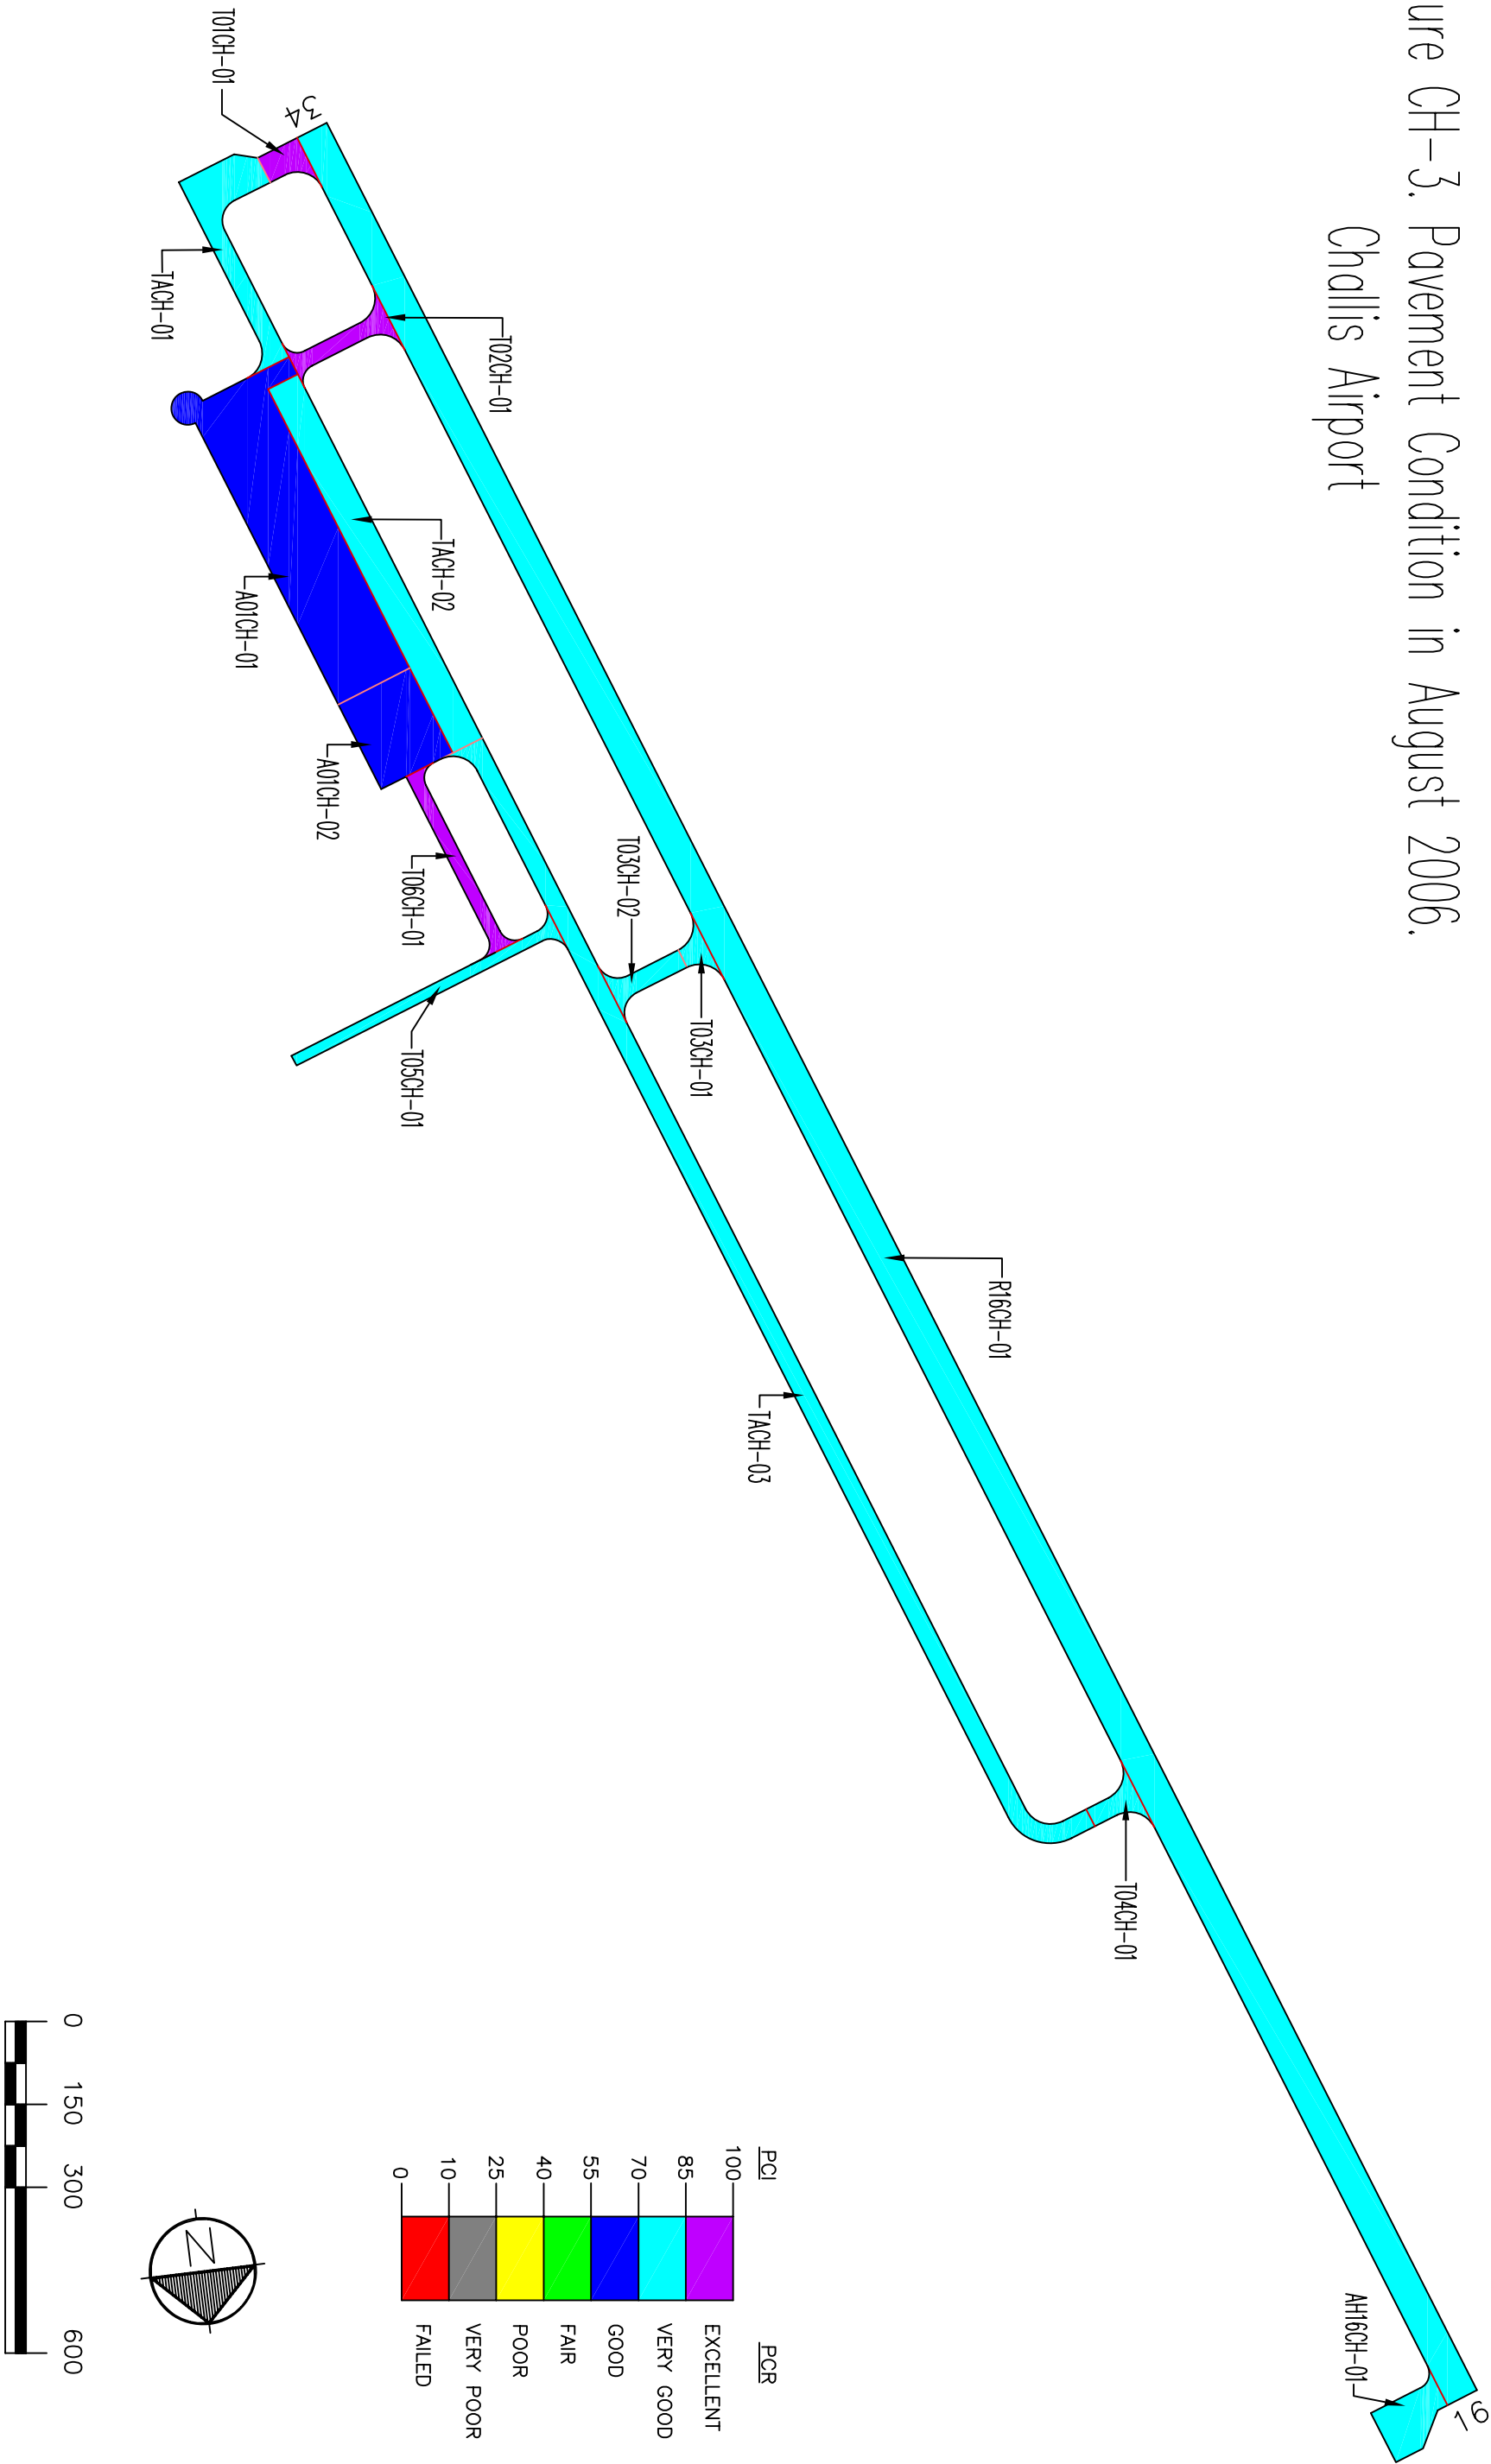
Figure CH-3. Pavement Condition in August 2006.  
Challis Airport

Section PCIs at the airport range from a low of 58 (a PCR of "Good") to a high of 100 (a PCR of "Excellent"). The area-weighted average PCI for all airport pavements is 76, corresponding to an overall PCR of "Very Good". Figure CH-4 shows how much pavement area is associated with each Pavement Condition Rating category and also shows pavement condition distribution from the inspections conducted in 1997 and 2000. A graphical representation of the projected PCRs presented in Table CH-2 is shown in Figure CH-5.

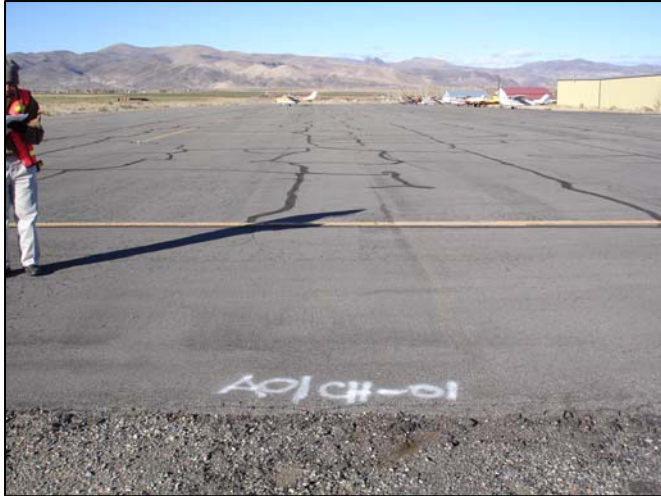
Sample Number:	01	Type:	R	Area:	5,000.00SqFt	PCI =	58
43	BLOCK CRACKING			L	3,999.97 SqFt		
43	BLOCK CRACKING			M	999.99 SqFt		
Sample Number:	08	Type:	R	Area:	5,000.00SqFt	PCI =	58
43	BLOCK CRACKING			L	3,999.97 SqFt		
43	BLOCK CRACKING			M	999.99 SqFt		
Sample Number:	10	Type:	R	Area:	5,000.00SqFt	PCI =	58
43	BLOCK CRACKING			L	3,999.97 SqFt		
43	BLOCK CRACKING			M	999.99 SqFt		
Sample Number:	12	Type:	R	Area:	5,050.00SqFt	PCI =	58
43	BLOCK CRACKING			L	3,999.97 SqFt		
43	BLOCK CRACKING			M	1,049.99 SqFt		
Sample Number:	15	Type:	R	Area:	4,500.00SqFt	PCI =	58
43	BLOCK CRACKING			L	3,599.97 SqFt		
43	BLOCK CRACKING			M	899.99 SqFt

Section: A01CH-01  
Block Cracking

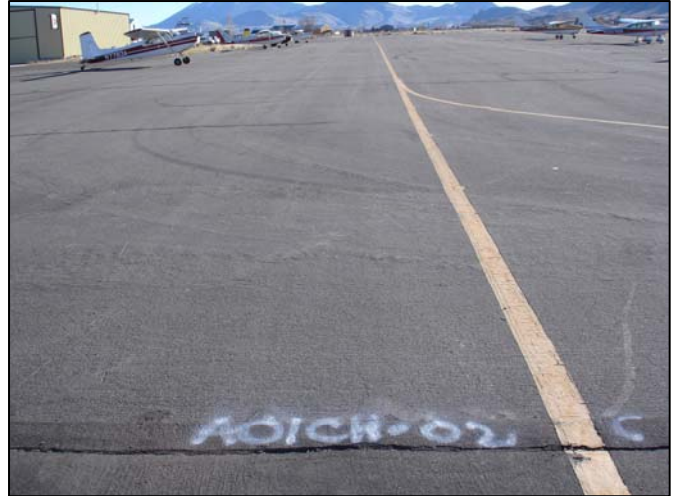
Sample Number: 01 Type: R Area: 5,000.00SqFt PCI = 59  
43 BLOCK CRACKING M 320.00 SqFt  
48 LONGITUDINAL/TRANSVERSE CRACKING M 215.06 Ft  
48 LONGITUDINAL/TRANSVERSE CRACKING L 90.02 Ft  
43 BLOCK CRACKING L 600.00 SqFt

Sample Number: 05 Type: R Area: 4,500.00SqFt PCI = 44  
43 BLOCK CRACKING M 1,499.99 SqFt  
48 LONGITUDINAL/TRANSVERSE CRACKING M 268.07 Ft  
43 BLOCK CRACKING L 1,499.99 SqFt

Section: A01CH-02  
Block Cracking

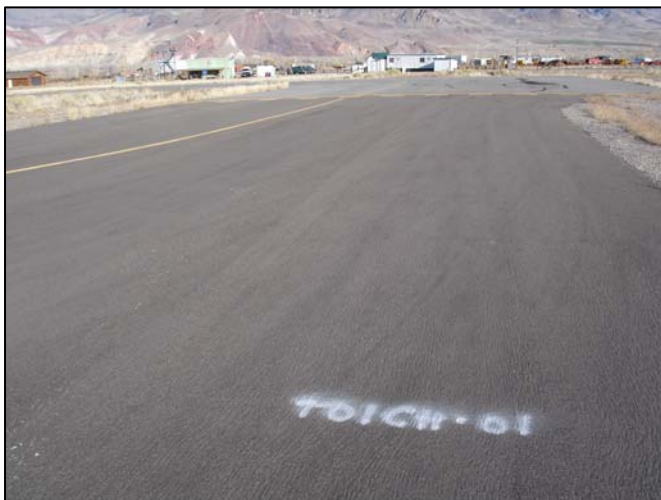
Section: T01CH-01  
No Distress

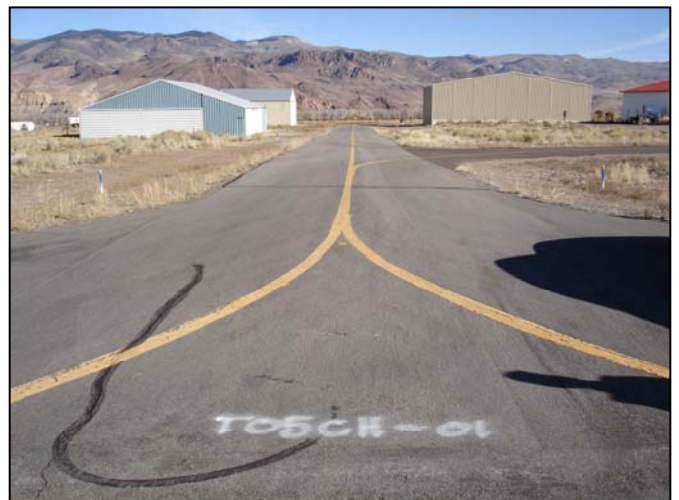
Sample Number:	01	Type:	R	Area:	6,526.00SqFt	PCI =	76
48	LONGITUDINAL/TRANSVERSE	CRACKING		L	124.03 Ft		
48	LONGITUDINAL/TRANSVERSE	CRACKING		M	194.05 Ft		
Sample Number:	02	Type:	R	Area:	4,660.00SqFt	PCI =	66
48	LONGITUDINAL/TRANSVERSE	CRACKING		L	90.02 Ft		
48	LONGITUDINAL/TRANSVERSE	CRACKING		M	45.01 Ft		
52	WEATHERING/RAVELING			H	80.00 SqFt

Section: T05CH-01  
Longitudinal/ Transverse Cracking

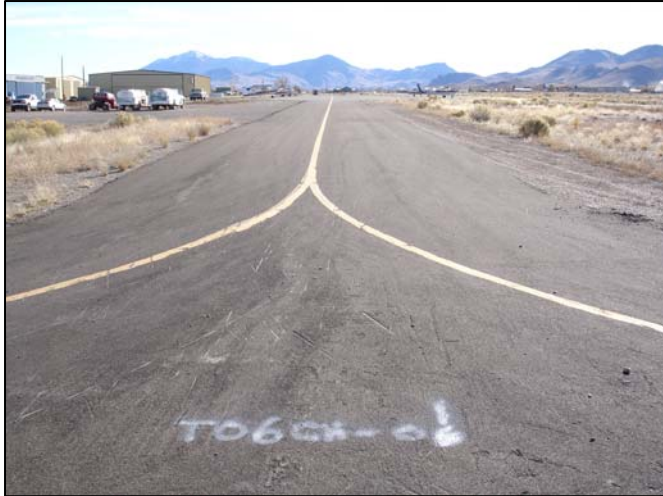
Sample Number:	01	Type:	R	Area:	5,193.00SqFt	PCI =	87
48	LONGITUDINAL/TRANSVERSE	CRACKING		L	9.00 Ft		
48	LONGITUDINAL/TRANSVERSE	CRACKING		M	45.01 Ft		
Sample Number:	02	Type:	R	Area:	4,299.00SqFt	PCI =	97
48	LONGITUDINAL/TRANSVERSE	CRACKING		L	5.00 Ft

Section: T06CH-01  
Longitudinal/ Transverse Cracking
